HELWAN UNIVERSITY - EGYPT  
HUM EERI STUDENT CHAPTER  
YEAR 2020 - 2021

- 01. INTRODUCTION
- 02. ARCHITECTURAL CHALLENGE
- 03. ENVIRONMENTAL CHALLENGE
- 04. STRUCTURAL CHALLENGE

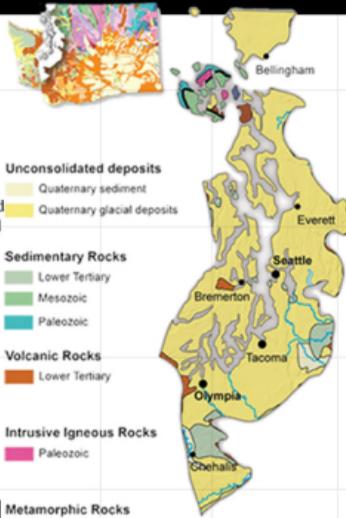
**Extent of the Puget Lobe of the Cordilleran Ice Sheet during the latest ice advance**

Glaciers are ice sheets that can be thousands of feet thick and are exceptionally talented at transforming landscapes. It was during the Vashon Stade (the latest ice advance and retreat about 15,000–12,000 years ago) that the Puget Lowland got the extreme make-over that we see today.

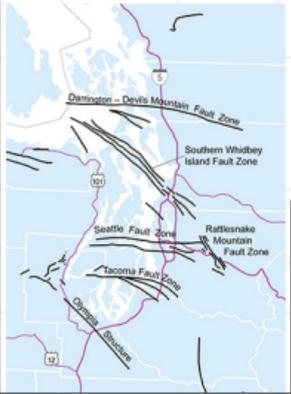
**Major Faults in the seattle area**

Several major fault zones traverse the province, including the Seattle Fault, the Tacoma fault, the southern Whidbey Island fault, and the Darrington-Devils Mountain fault zone. These faults are capable of producing earthquakes and lie within densely populated areas

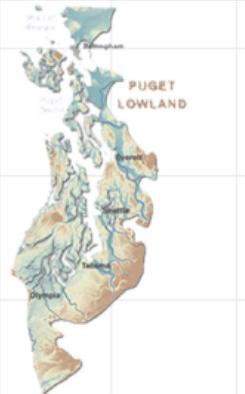
**The Puget Lowland region**

The Puget Lowland region is a wide low-lying area between the Cascade Range to the east and the Olympic Mountains to the west. The region extends from the San Juan Islands in the north to past the southern end of the Puget Sound. It is known for its scenic coastlines, bustling urban ports, and rich farmlands to the south. The natural resources and the geologic history of the Puget Sound and surrounding areas have helped to shape the history of the Washington state

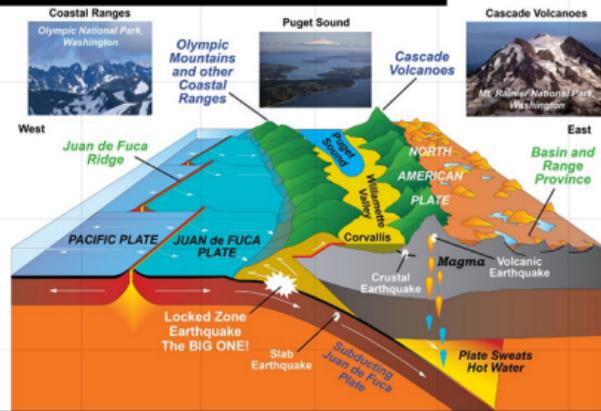
## Cascadia Subduction Zone

The Cascadia Subduction Zone plate interface slips every few hundred years in very large earthquakes with magnitudes approaching or even above 9.0. These earthquakes generate dangerous tsunamis similar to the 2011 magnitude-9.0 Tohoku-Oki earthquake and accompanying tsunami in Japan.

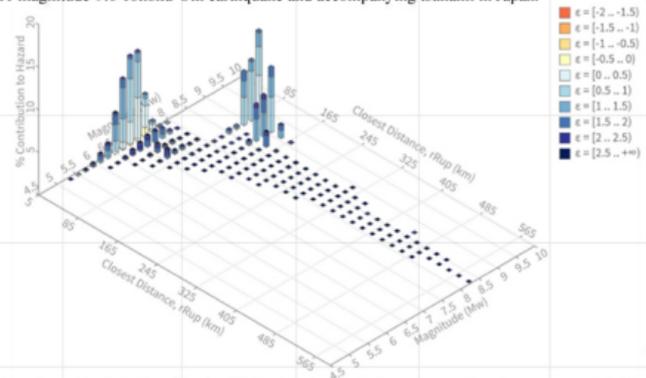
## USGS DE aggregation plot

The seismic hazard calculations for the 1996 national seismic hazard maps have been geographically de aggregated to assist in the understanding of the relative contributions of sources. These de aggregations are exhibited as maps with vertical bars whose heights are proportional to the contribution that each geographical cell makes to the ground-motion exceedance hazard. Bar colors correspond to average source magnitudes.

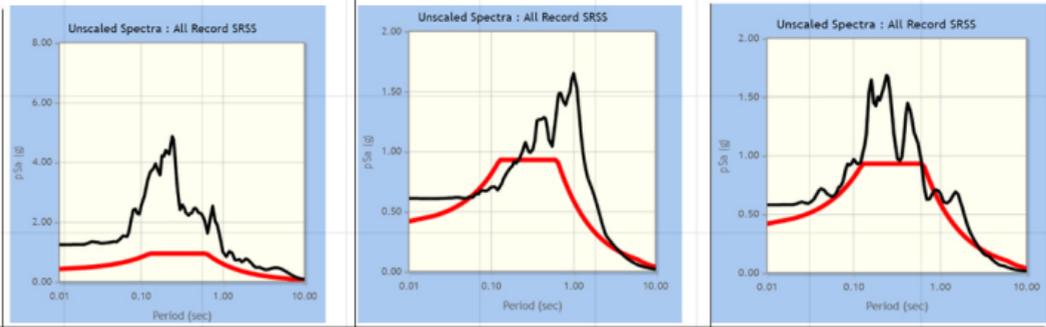
# Selecting appropriate ground motions to be scaled and applied on the model

Selecting motions to be scaled for later seismic analysis.  
(The Selection process depends on several parameters, such as:  $V_{S30} / M / R$  and the general shape of the GM in comparison to that of the design response spectrum)

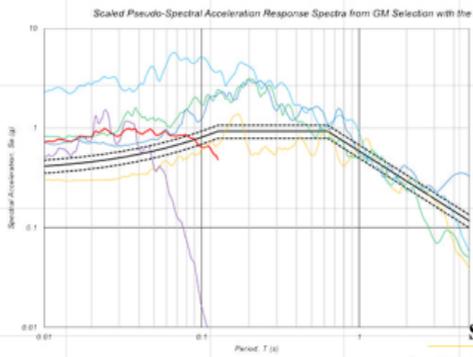
## Scaling of the selected ground motions

After the selection of several GMs, they are scaled to be used for analysis purposes

Seed Motion Name	Scale Factor
Seed Motion #1 (Subduction Interface)	1.130743476
Seed Motion #2 (Subduction Interface)	3
Seed Motion #3 (Reverse Crustal)	1.841634484
Seed Motion #4 (Reverse Crustal)	0.824827795
Centerville Beach_Naval Fac	1.06651025

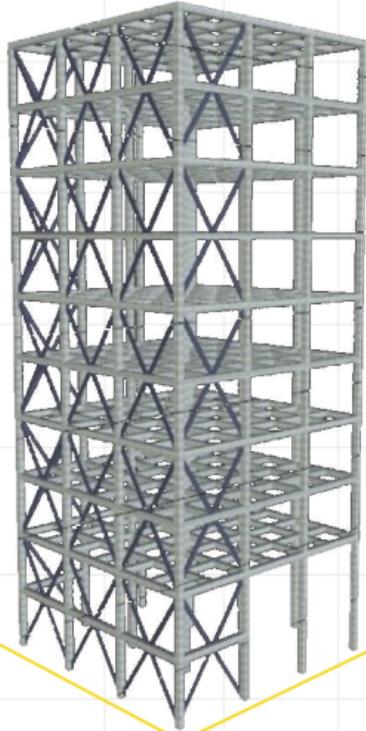
Roof of the existing building is connected with the first floor of the addition with X-Bracings across all 4 sides of the building.

Alternating between X-Braces and Global Bracings on the N/S sides of the building, with the mid-bay having only X-Braces and completely devoid of any global bracings.

On the west side. Also alternating between X and global bracings, having the last 3 floors connected with X-Bracings.

On the east side, another variation of bracings has been introduced, in which we use a combination of V & Inverted

V-Bracings with global bracings
