Introduction

Structural

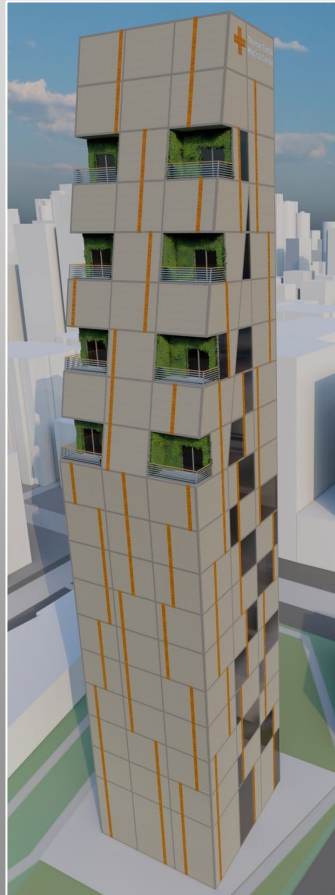
Inspired by Amazon Tower 1, the *Thomas Tuttle Medical Center* aims to achieve conformity with the iconic Seattle skyline with the addition of some flair. Vertical strips travel up the sides of the structure adding a pop of color to the grey exterior. Tinted windows give patients and medical professionals breathtaking views of the Seattle skyline and neighboring Elliot Bay while simultaneously providing privacy from the bustling surroundings.

The addition provides balconies to both mobile and bed bound patients access to open air. All balconies are equipped with a living walls for patient well-being and sustainability. It is projected to obtain LEED certification with diversified transportation amenities, rainwater management, water efficiency, and the optimization of building materials for a total of 42 points on the BD+C Scorecard.
