# SYMBIOSIS

Symbiosis is a hospital with resilience and purpose at the forefront of its design. As we have become more reliant on our emergency rooms during this pandemic, the hospital needed an addition to create space for the influx of patients. This addition prompted a retrofit of the existing structure to ensure the hospital stays open during any disaster. The façade evokes a sense of familiarity while still pushing the boundaries of modern hospital design, keeping the Belltown neighborhood ahead of the times. Symbiosis serves the community, the environment, and the front-line workers who are tirelessly ensuring the health and safety of Seattle.

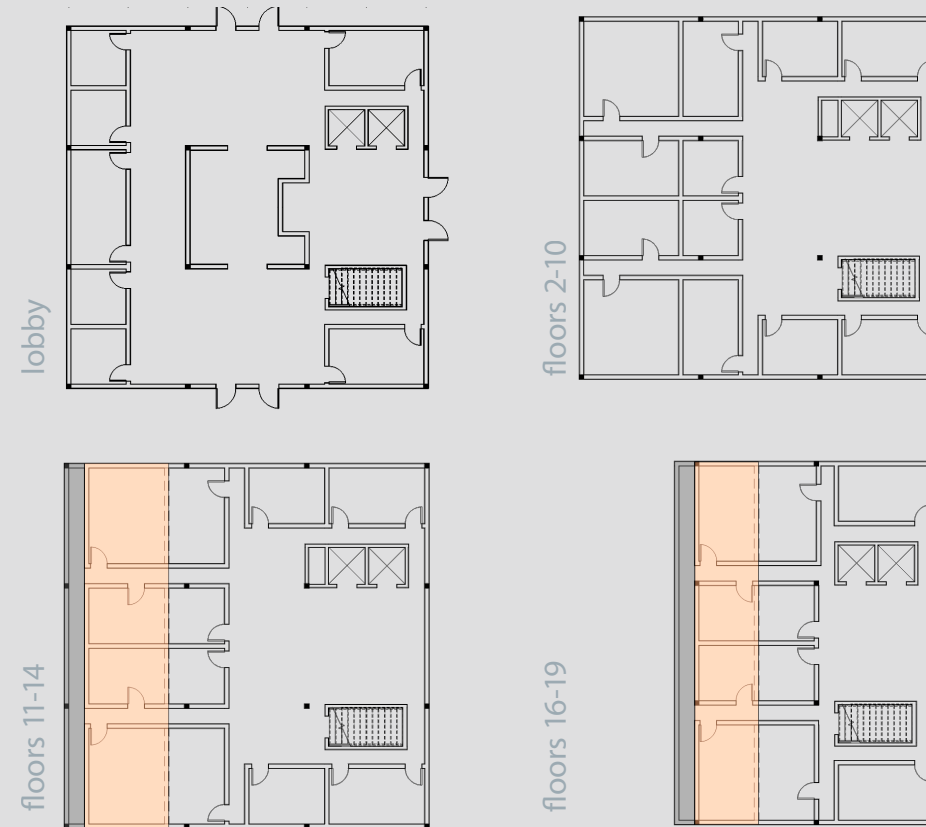
Inspired by the trendy neighborhood site of Belltown and the nearby Olympic Sculpture Garden, the bold colors and organic forms seen throughout, were wrapped around the hospital in a façade that allows fantastic views of Elliott Bay and sets a striking precedent for the modern hospital.

The internal layout of the hospital features patient rooms pushed towards the edges of the building for privacy and added sunlight. Circular walkways increase circulation, and multiple access points and passageways to keep patients with different conditions separate. The floor layouts stay familiar and consistent at each level of the hospital.

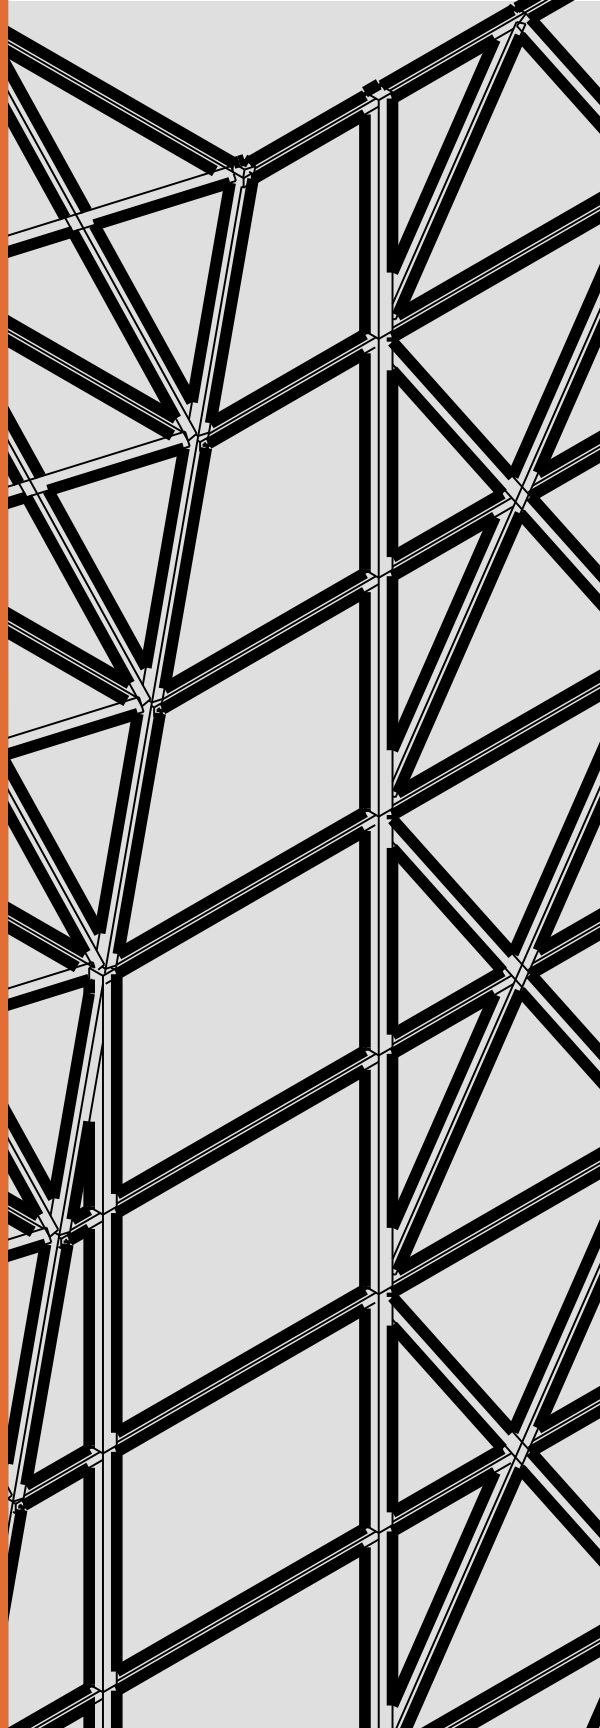
After a series of iterations to combat the existing irregular design, an extension brace layout was selected. The chosen design incorporated single story X-bracing along the sloping face to match the existing scheme and maintain architectural appeal. In addition, two-story X-bracing was placed at the east view in an effort to eliminate torsional irregularities. Two-story X-bracing was also placed on the north and south faces to provide stiffness in those directions. The final iteration incorporates a belt truss at the tenth story to drag forces from the addition to the existing structure.

Given construction documents for the existing hospital building, a base ETABS model was generated for analysis. During this phase, dead load was applied to the floors and scaled ground motions were run through the structure. The dominant mode shapes of the model were mainly torsional, due to the irregular brace design.

Maximum member forces for the existing structure were compared to hand calculated capacities to determine if any failure occurred. Further outputs of inner-story drift ratios were displayed, where the maximum across all ground motions occurred in the north-south direction between stories 6 and 7.

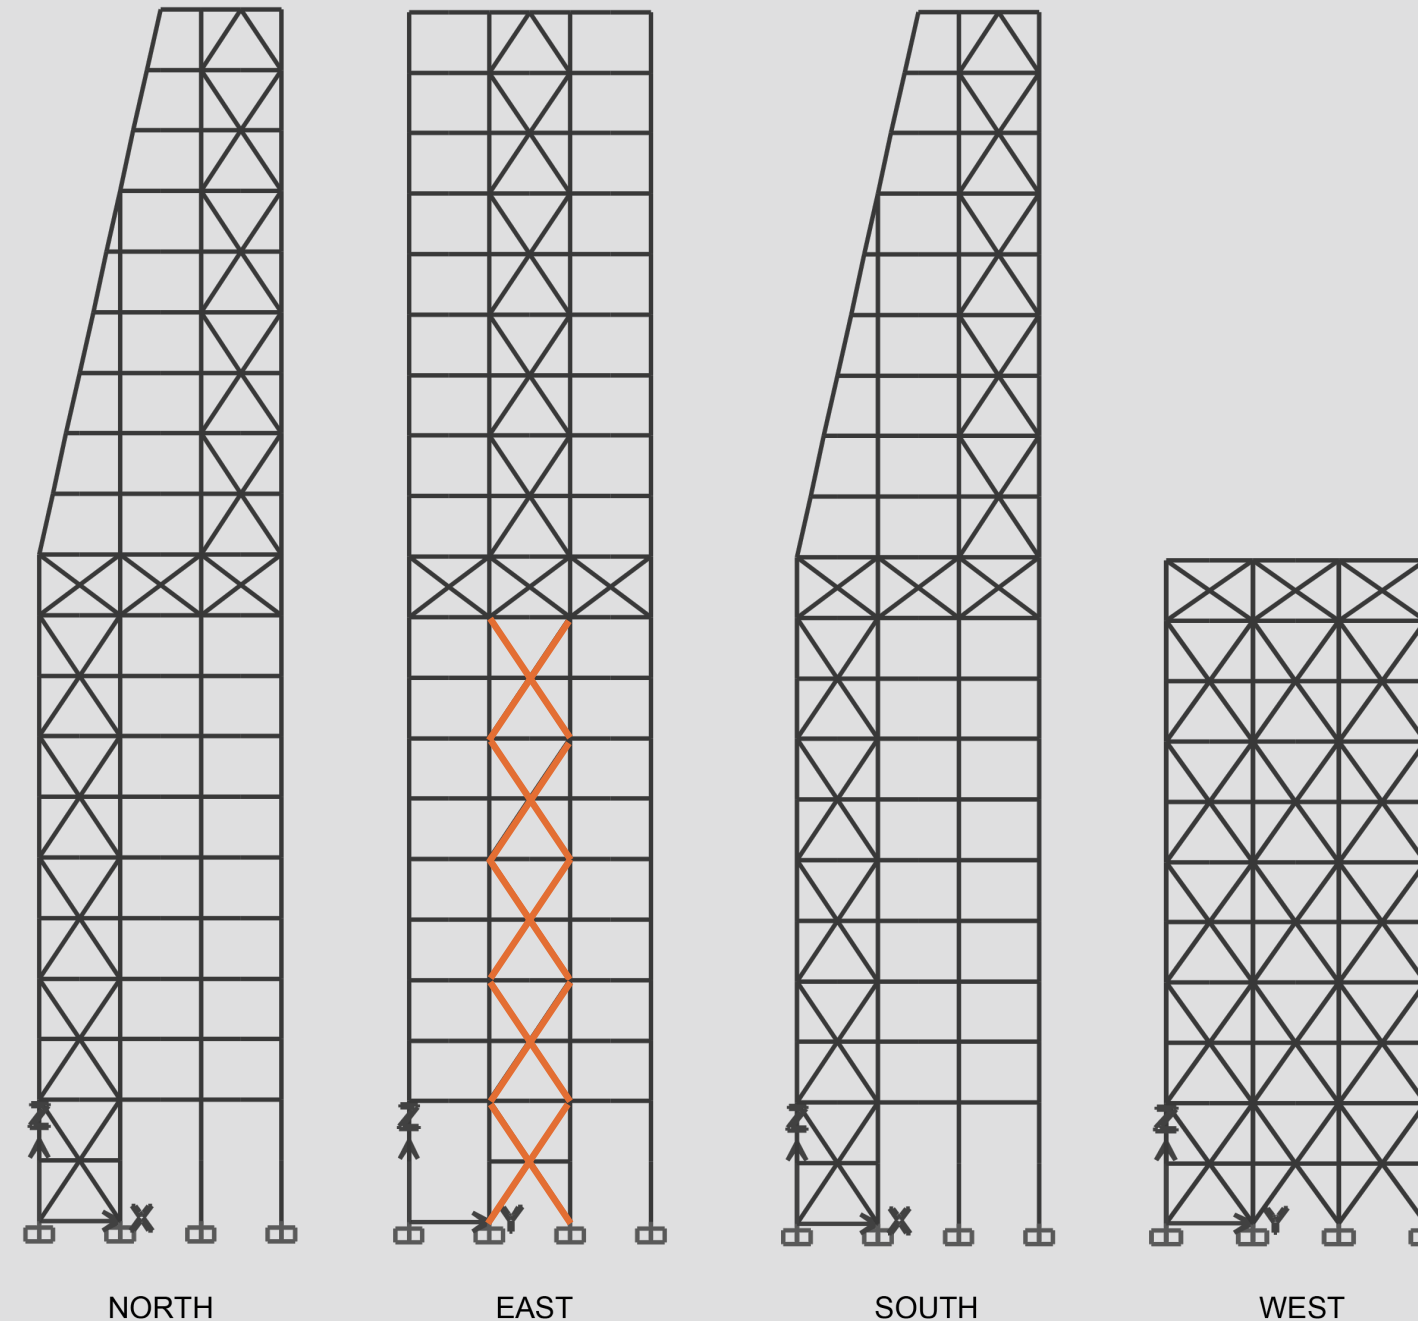
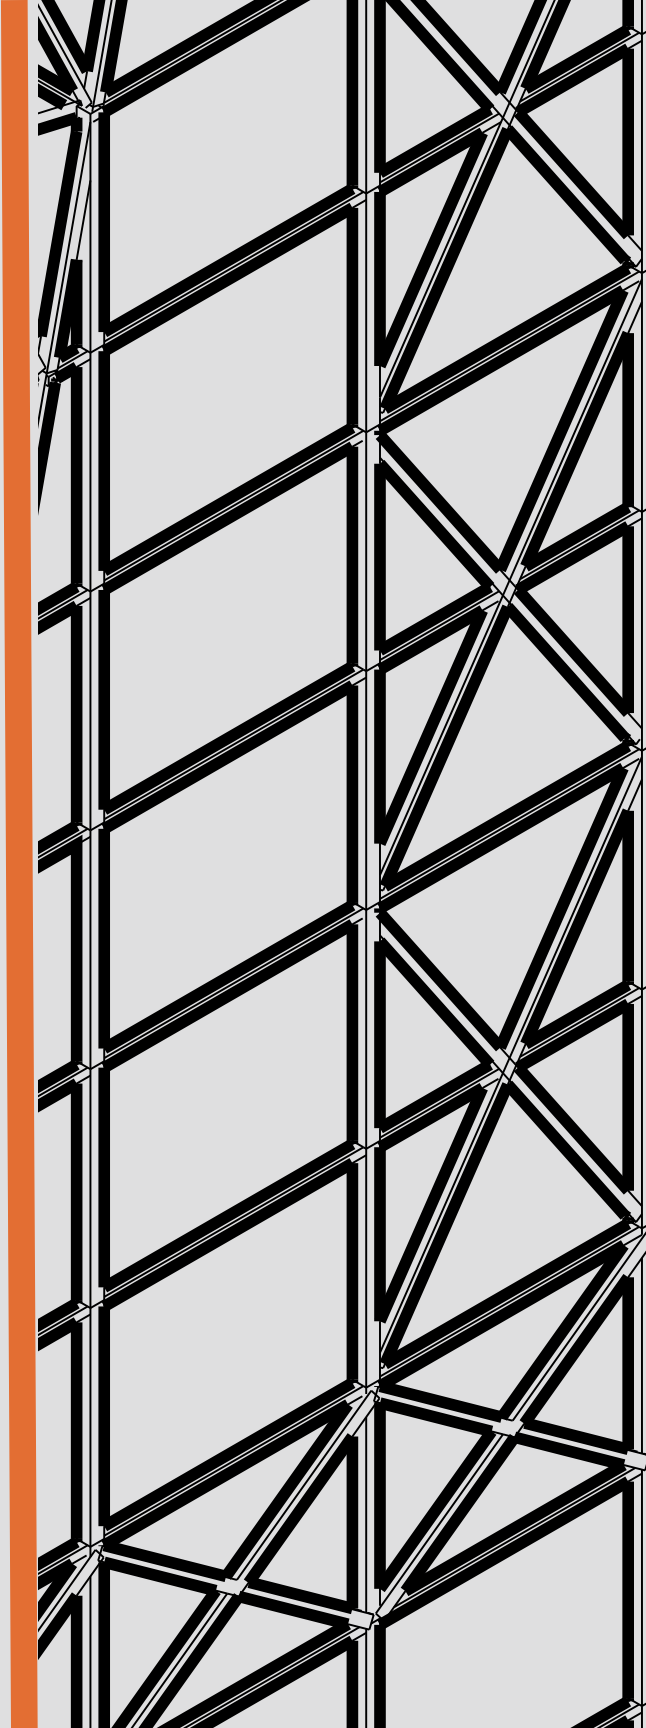
The retrofit scheme of adding braces was selected to combat high displacement ratios and to accommodate the failure of the existing structure with the addition. A series of vertical braces were added from the base to floor 10 on the east face of the building.

This series of five, two-level braces, in combination with an adjusted bracing layout for the modified addition, proved to allow the structure to perform well in terms of member capacity and drift. An edited scheme for the addition was that of eliminating braces on the outer bays of the east face, to reduce stiffness. Collectively, this final design performed well in all regards.

The annualized collapse risk ( $\lambda_c$ ) was calculated by combining collapse fragility and the seismic hazard curve resulting in a value of 0.0396%. Assuming a Poisson distribution of the probability of collapse, the 50-year collapse risk ( $x$ ) was calculated to be 1.96%. This value exceeds ASCE-7 guidelines which set a maximum limit for the collapse risk in 50-years to be 1%. Therefore, a retrofit scheme with a minimum collapse probability reduction factor ( $m$ ) of 1.9682 is necessary to reduce the 50-year collapse risk of the existing hospital with addition to 1.00%.
