NIGHTINGALE HOSPITAL-SEATTLE

Earthquake Resistant
Building for
COVID-19 Patients

IIIT BOMBAY

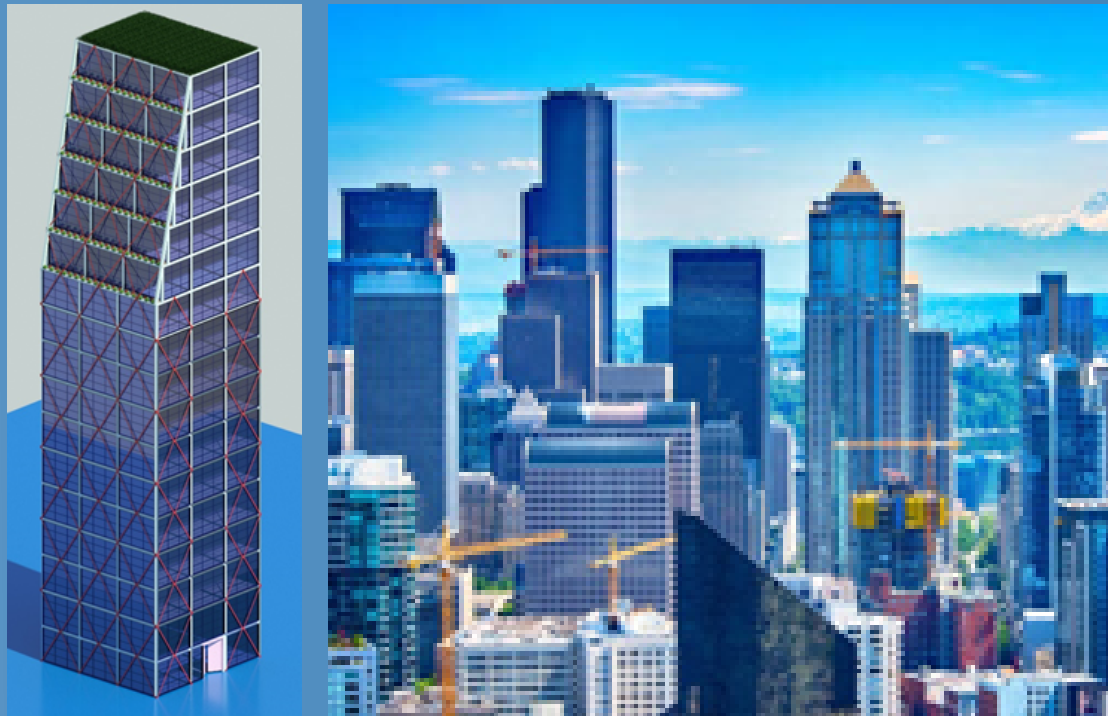
Building Façade with Seattle Skyline

- Maximum exposure to the outside
- Accomodate bracing system
- Matching with regional trends
- Eco-Sense glass facade
